# Manhole Inspection Summary

## Manhole # S43K2\_006MH

Insp Date: **4/29/08 9:57 AM**

**Location** Address: **1000 Church St.**

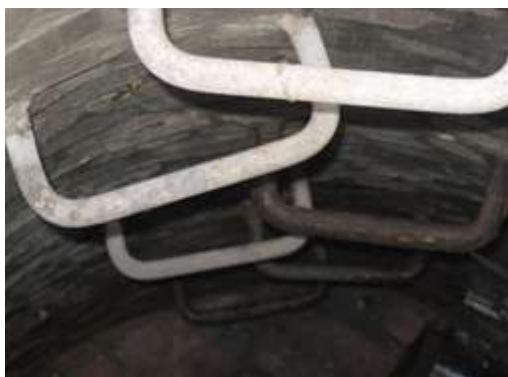
Steps

Count: **6** Missing: **0** ☒ **Corroded**

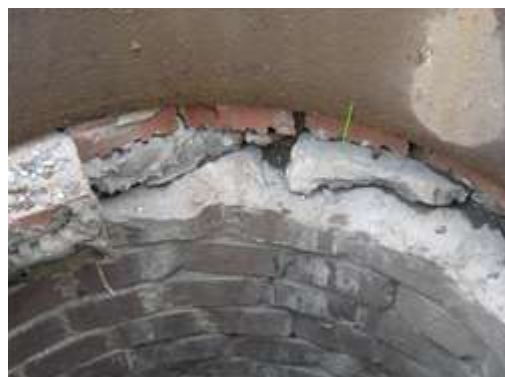
Defect 2

Condition: ☐ Sound ☐ Cracked ☐ Root Intrusion ☐ Loose Brick ☒ **Deteriorated**

Infiltration: ☐ None ☒ **Joint** ☒ **Cracks** ☐ Mortar ☐ Roots ☐ Wall

Chimney (Cracked)

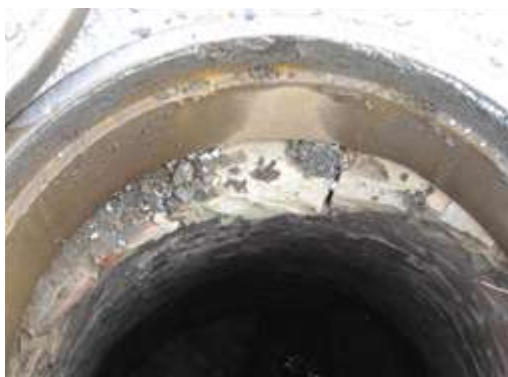
Defect 1

Offset: **3** (in.)

Frame Offset

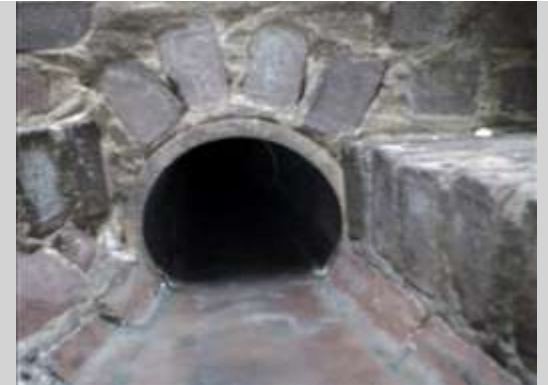
12 O'Clock Outflow

8 in. Circular Gravity Sewer  
Pipe Out @ 12 O'Clock

Pipe Height: **8.4** (in.) Rod and Bar (Angled)  
Pipe Material: **Clay** ☐ Pipe Lined  
Invert Depth: **10.26** (ft.) Flow Characteristics: **Fast**  
Deposits: ☒ None ☐ Mud ☐ Sludge ☐ Debris ☐ Grease  
Silt Depth: (in.) Deposits Extent:  
Infiltration: **None** Pipe Seal Cond: **Sound**

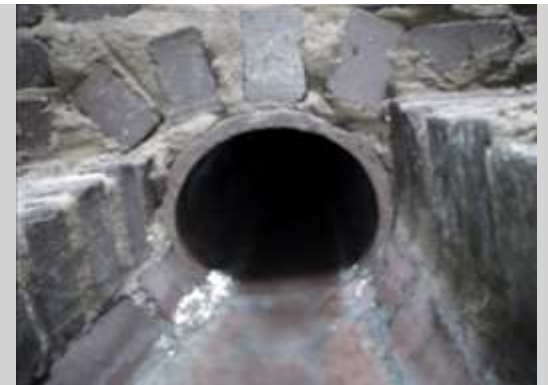
6 O'Clock Inflow

8 in. Circular Gravity Sewer  
Pipe In @ 6 O'Clock

Pipe Height: **8.4** (in.) Rod and Bar (Angled)  
Pipe Material: **Clay** ☐ Pipe Lined  
Invert Depth: **10.06** (ft.) Flow Characteristics: **Fast**  
Deposits: ☒ None ☐ Mud ☐ Sludge ☐ Debris ☐ Grease  
Silt Depth: (in.) Deposits Extent:  
Infiltration: **None** Pipe Seal Cond: **Cracked**

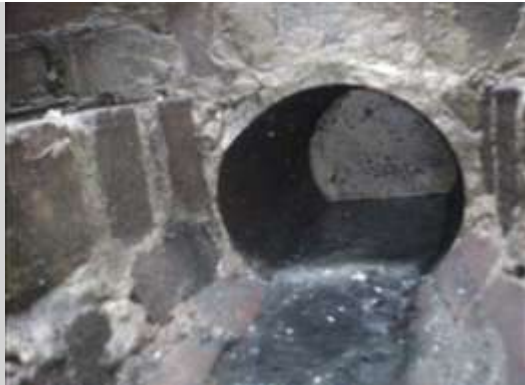
9 O'Clock Inflow

6 in. Circular Gravity Sewer

Pipe In @ 9 O'Clock

Pipe Height: **8.4** (in.) Rod and Bar (Angled)

Pipe Material: **Clay** ☐ Pipe Lined

Invert Depth: **9.97** (ft.) Flow Characteristics: **None**

Infiltration: **None**

Pipe Seal Cond: **Sound**
